Please accept the following comment on the (API-105-21374) Clara 20 injection well permit application.

On 5/27/22 the DEP oil and gas well inspector inspected the Clara 20 well and at the time of the inspection took the following photo.

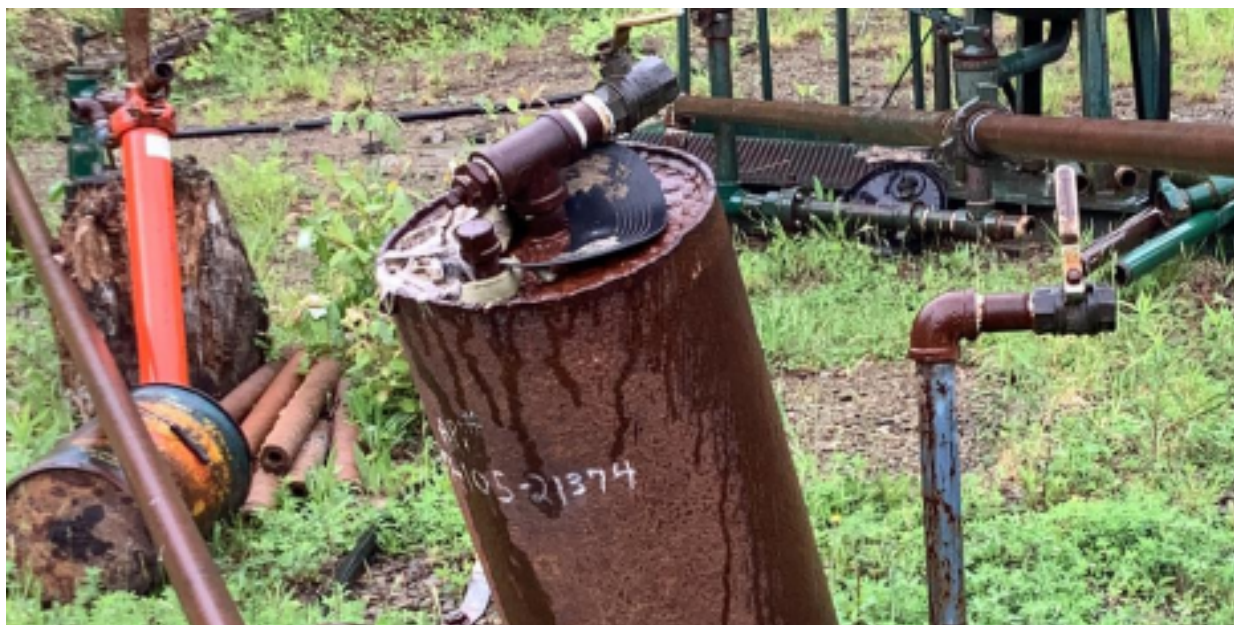
At the time the inspector noted that the department received an application from the operator to convert the Clara 20 well from an active gas well into an injection well. During the inspection the inspector photographed the well, a rusty barrel, misc pipes and other un-used equipment littering the Clara 20 well site.

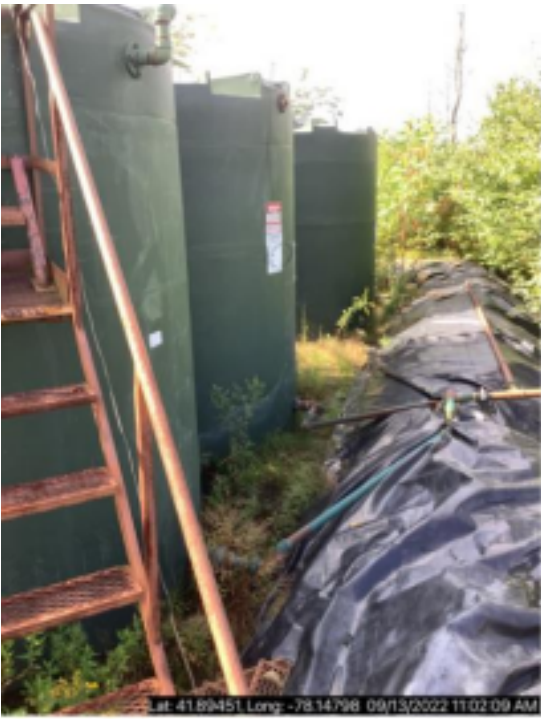
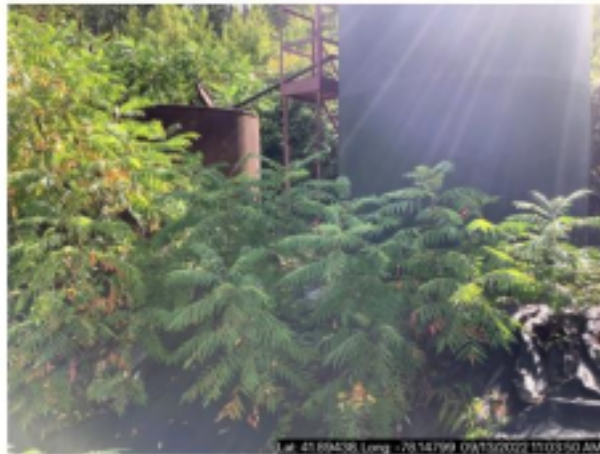
#: 5

Tanks labeled brine, no indication of tank volumes.

1: Production Fluids Control & Storage : Production Fluids Control & Storage	<b>Inspection Remark:</b> Four plastic tanks are located on site. One plastic separator tank, and three 100 barrel brine storage tanks. <b>Tank volumes are not listed on tanks.</b> Tanks appear to be in fair condition (photos 3-5).	<input checked="" type="checkbox"/> <input checked="" type="checkbox"/> <input type="checkbox"/>

1: Temporary Storage:	<b>Inspection Remark:</b> One 500 barrel frac tank is set up within an earthen dike along the site access road (photo 7). <b>The Department recommends labeling the tank for contents.</b>	<input checked="" type="checkbox"/> <input checked="" type="checkbox"/> <input type="checkbox"/>

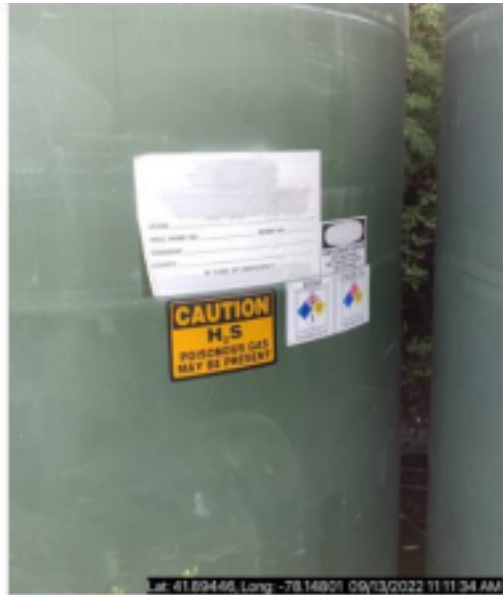
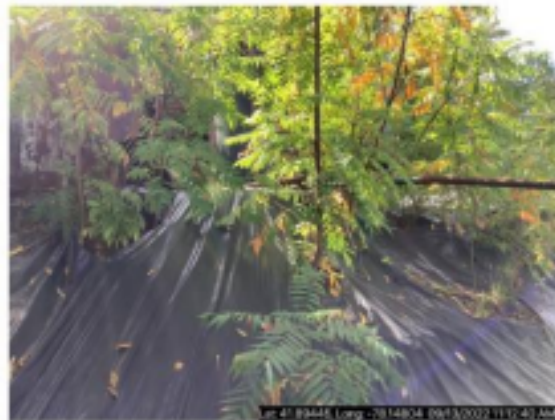
#: 6

Plastic liner under tanks with vegetation growing through liner material.

The Clara Field 20 well area was observed to be **overgrown with vegetation** during this inspection. Brine tanks on site are located within lined, earthen dikes. The liner for the upper tank and lower tank batteries **appears to have holes and vegetation growing through the material** (photo 4&6). Precipitation within liners was measured for electrical conductivity. No elevated conductivity readings were observed on site. **The Department recommends that all existing liners be removed and replaced with a more durable product which meets the Department requirements of §78.56.** Tanks appear to be in good condition.

1: Well Site Secondary Containment:	<b>Inspection Remark:</b> <b>Plastic liner membrane is installed under tank batteries. Liner material has perforations and vegetation growing through holes</b> (photos 3, 4&6).	<input checked="" type="checkbox"/> <input checked="" type="checkbox"/> <input type="checkbox"/>

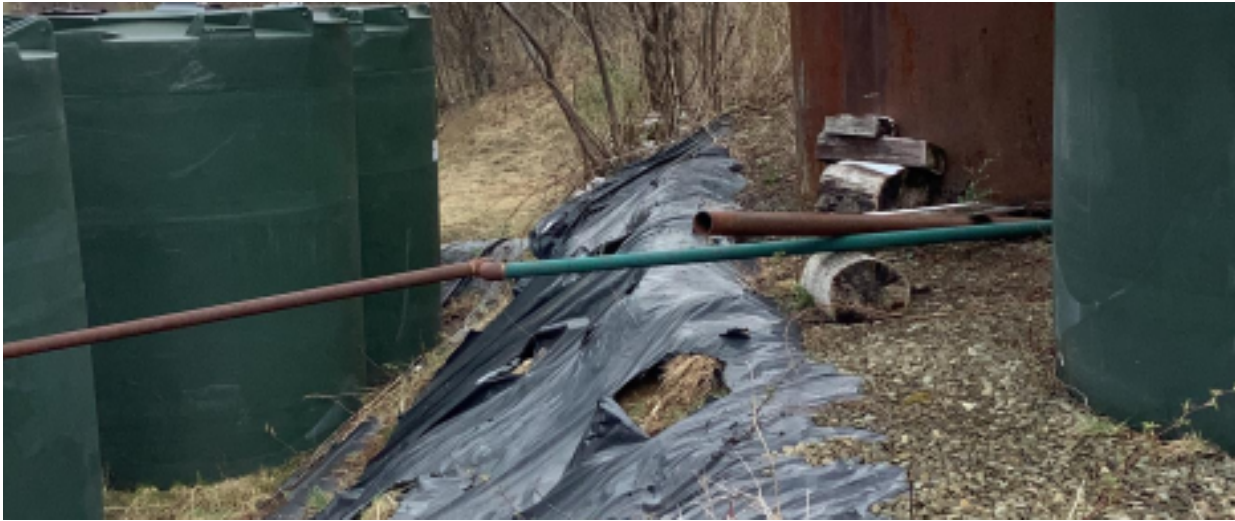
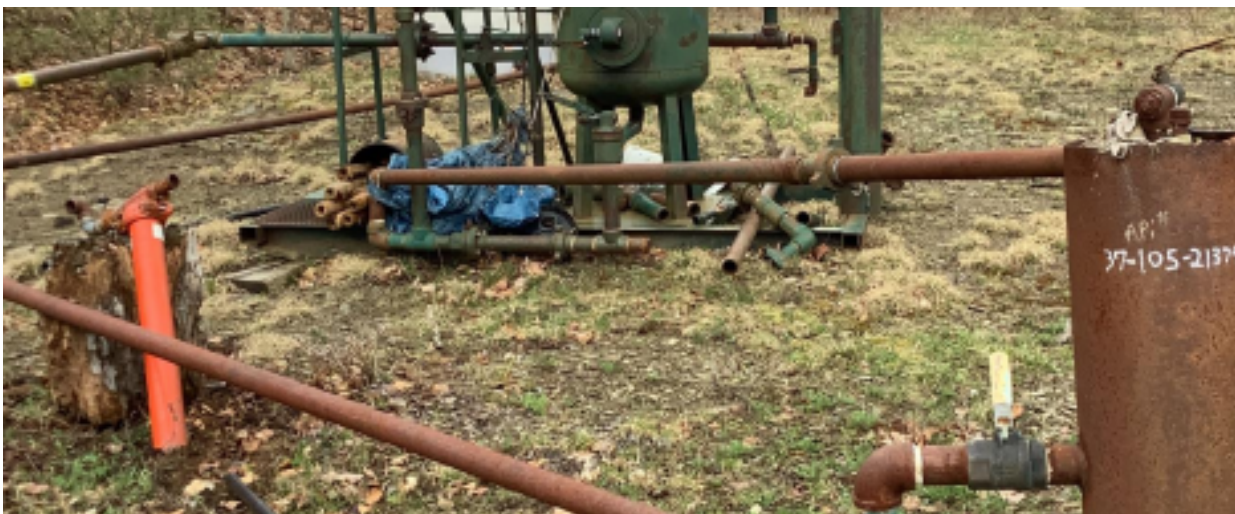
Photos taken during the April 18, 2023 inspection show that the trees that were growing through the liner were cut down.

The liner was not replaced and Roulette Oil and Gas was not cited for any violations during the April 18, 2023 inspection.

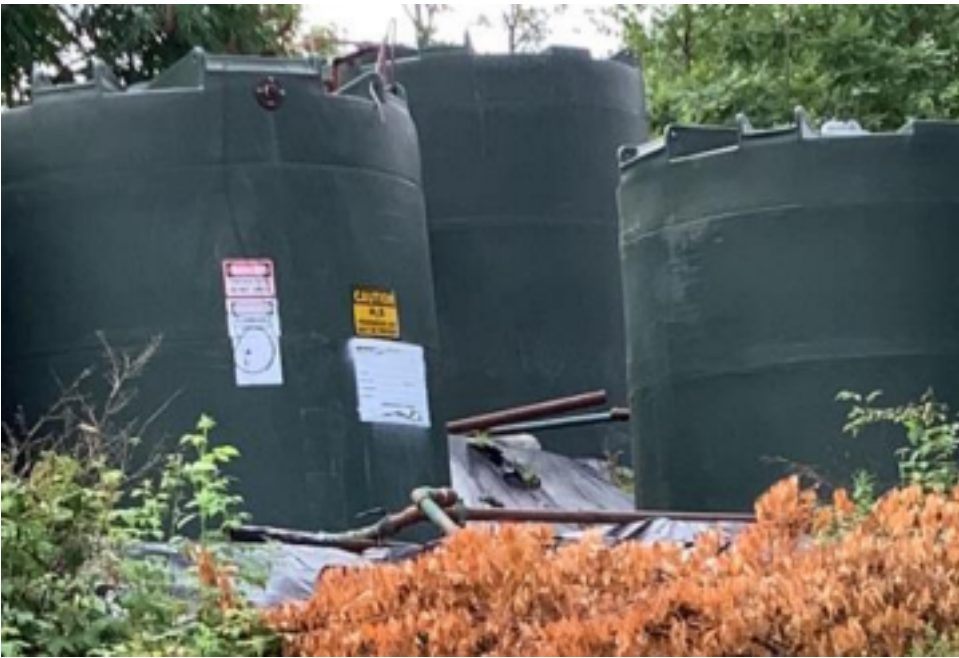
And it looks like the liner with the holes in it has not been replaced:
