Please accept the following comment on the (API-105-21374) Clara 20 injection well permit application.

On 5/27/22 the DEP oil and gas well inspector inspected the Clara 20 well and at the time of the inspection took the following photo.

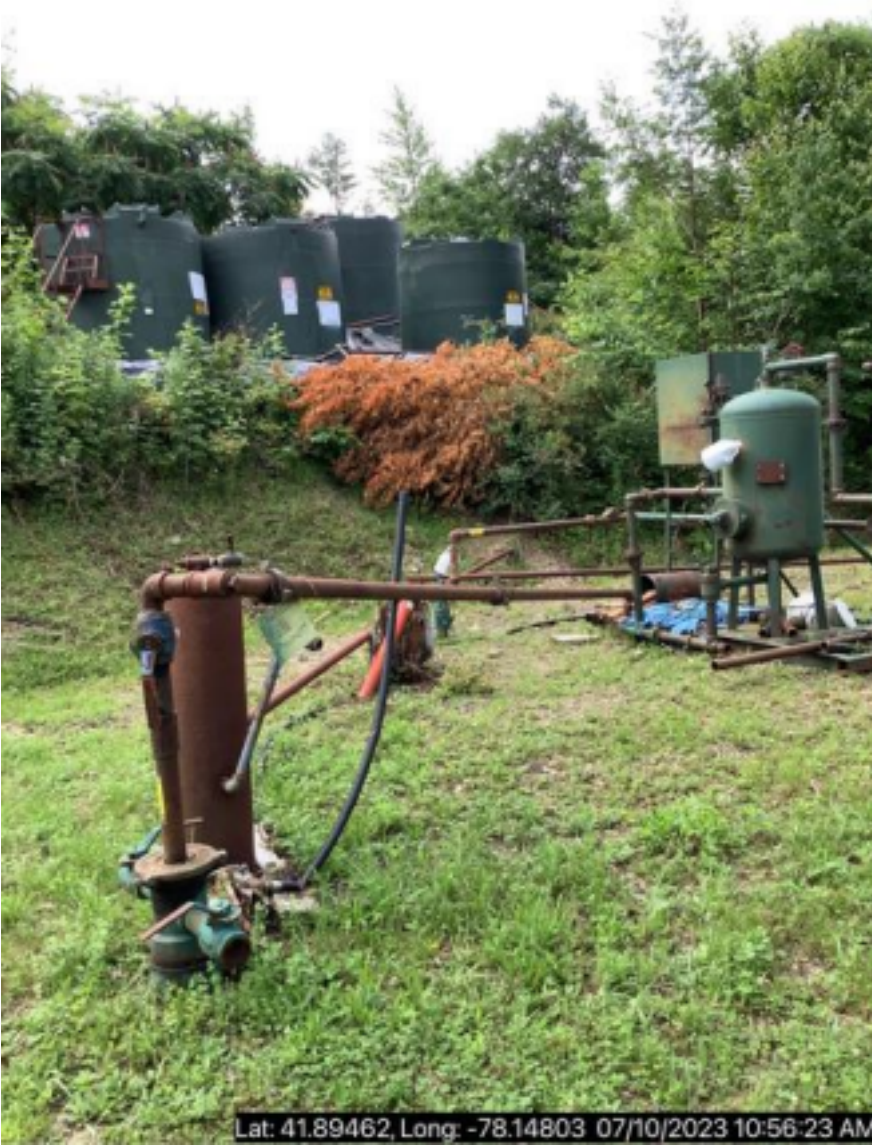
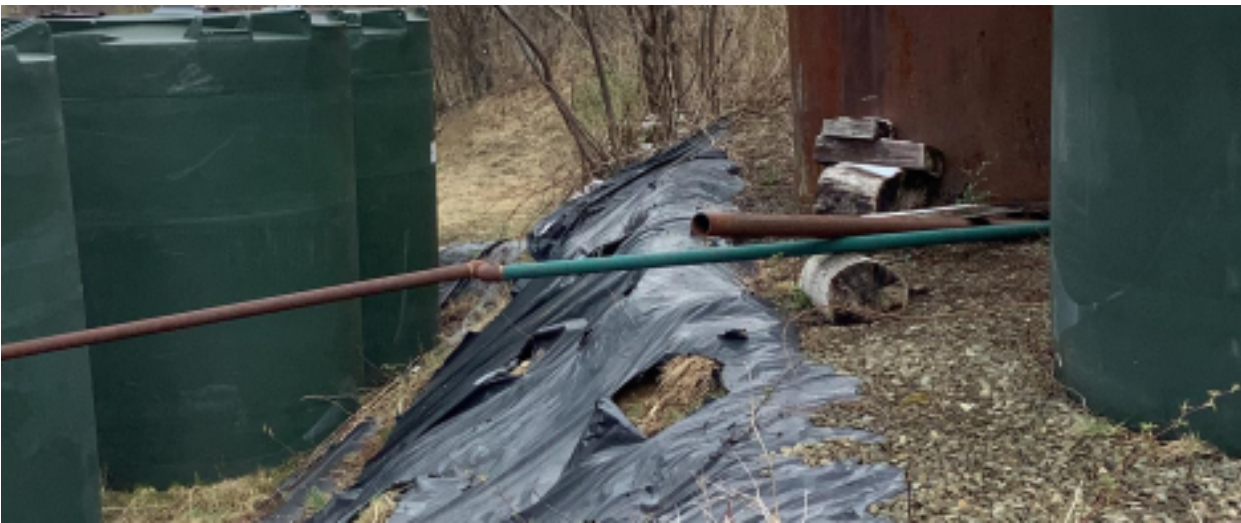
And it looks like the liner with the holes in it has not been replaced:

The operator was not cited for any violations during the 7/10/2023 inspection. Would you please explain the purpose of this secondary containment?

Is the condition of this **ACTIVE gas well** site and secondary containment around these **waste storage tanks** acceptable?
